2018 Temperatures & MLSA+CWRS Tphos at Site M4

2019 Temperatures & MLSA & CWRS Tphos at Site M4

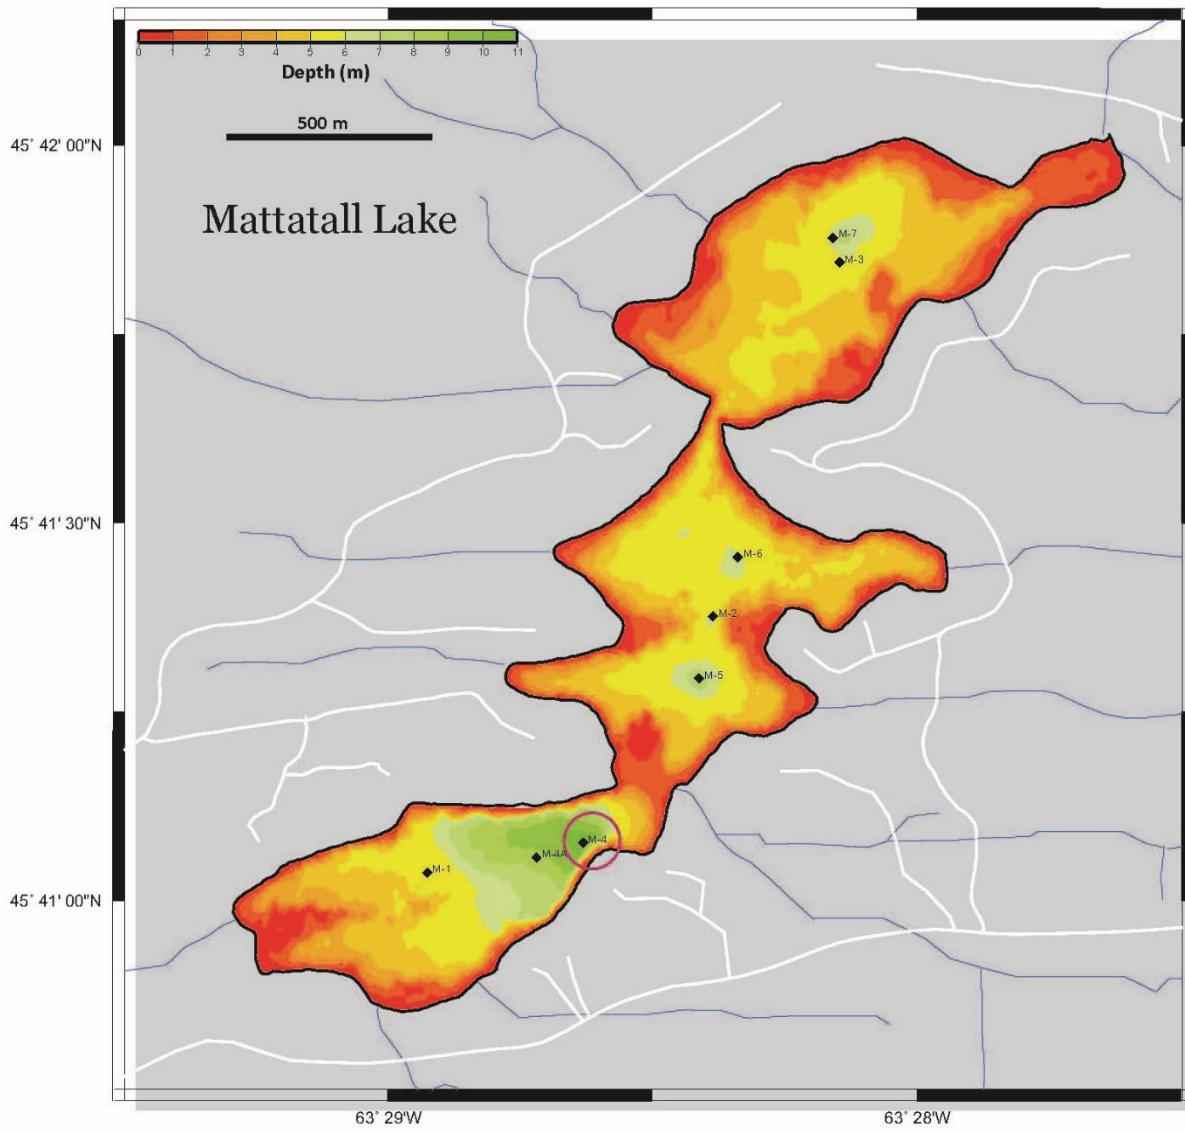
Map of water depths for Mattatall Lake from measurements taken by the MLSA. The location of site M4 is highlighted by the red circle.

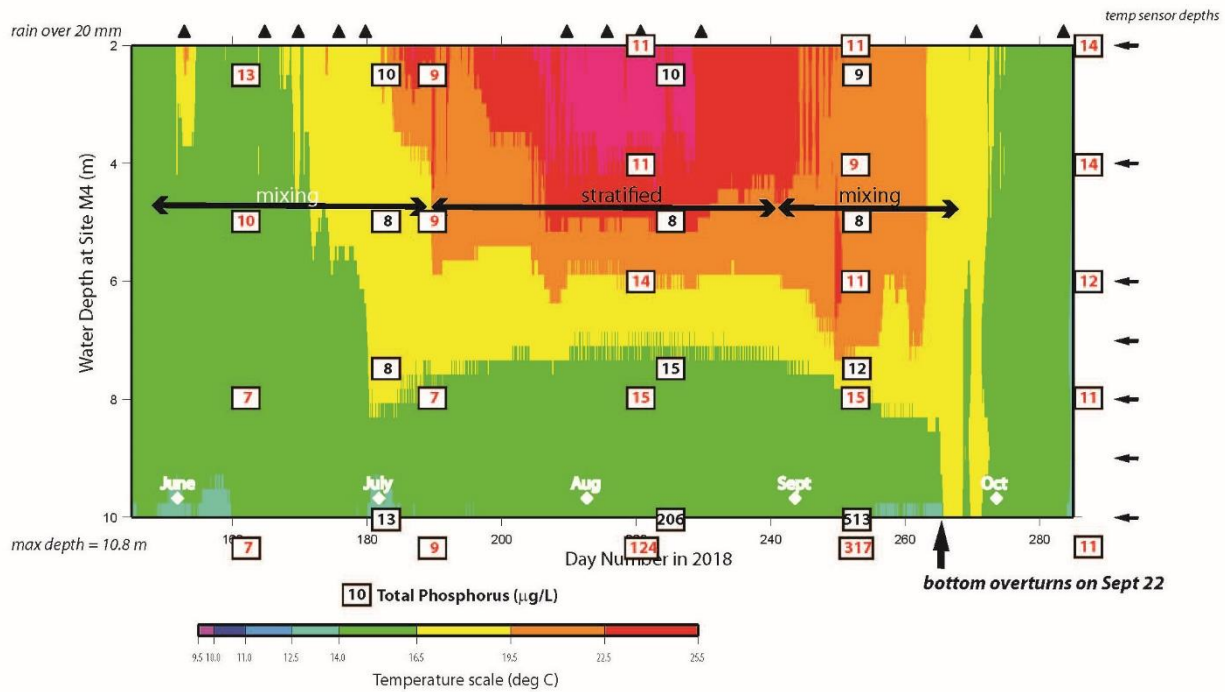
Plot of temperature vs. depth at site M4 in 2018 together with values of TP taken by MLSA (black) and CWRS (red)

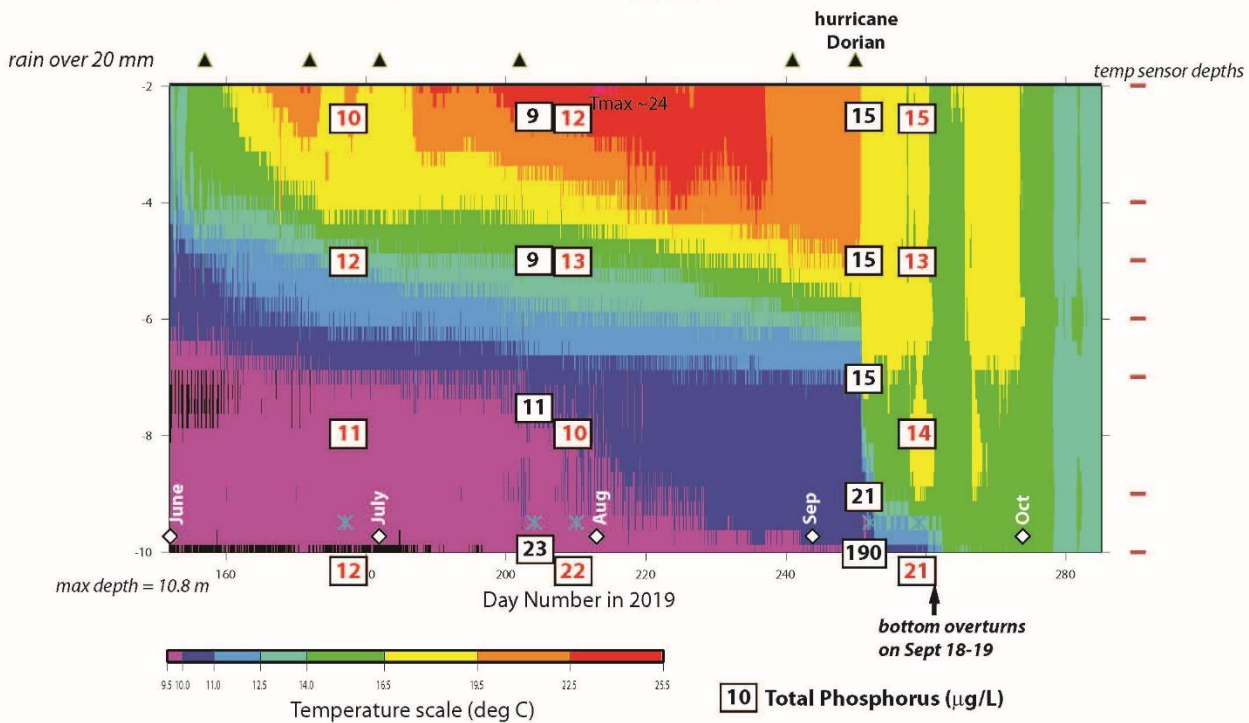
Plot of temperature vs. depth at site M4 in 2019 together with values of TP taken by MLSA (black) and CWRS (red)

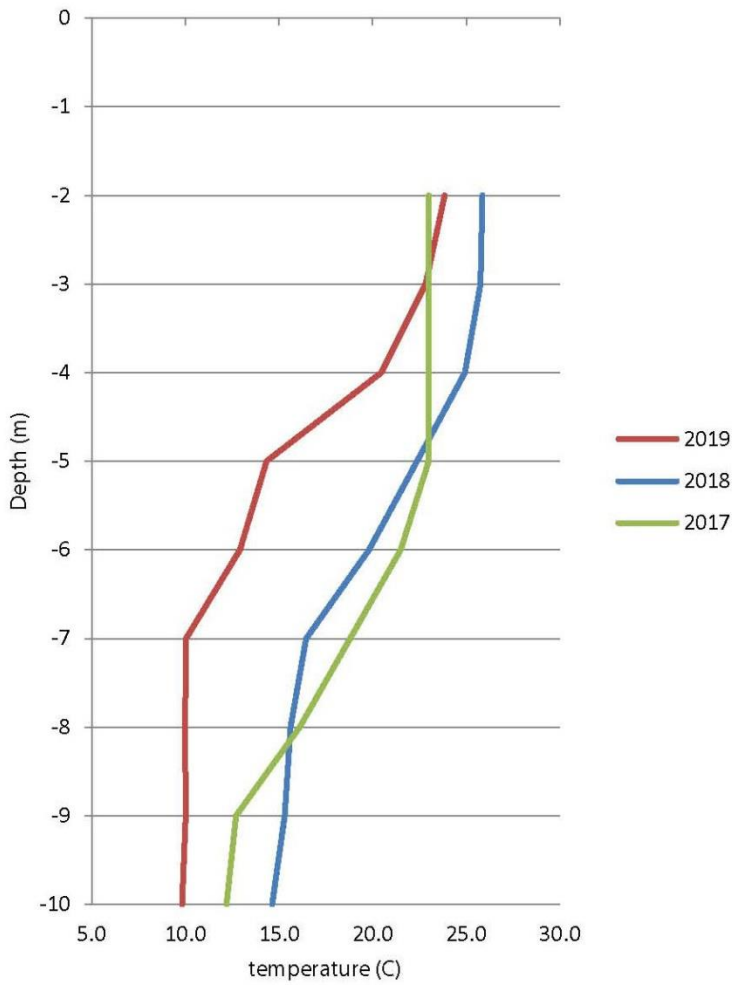
Temperatures on Aug 7 0900

Comparison of temperature vs. depth at Site M4 on August 7 at 0900 ADT for years 2017-2019. Data for 2017 was taken by CWRS; data for 2018 and 2019 were taken by MLSA.
